Multiple FEMA Grant Programs Ease Flood Worries

Full Mitigation Best Practice Story

Coos County, New Hampshire

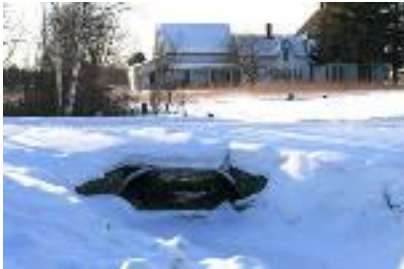
Concrete and Aluminum Culverts

A concrete 12 by 5 foot bottomless box culvert with wing walls was installed under Depot Street with funds from FEMA's Pre-Disaster Mitigation (PDM) Grant Program, which provides funding to states and local governments for implementing cost-effective hazard mitigation planning and projects before disasters occur. The PDM Program is a nationally competitive program with a goal to reduce the overall risk to people and property from future disasters, while also reducing reliance on funding from disaster declarations. The box culvert was completed in the fall of 2008 at a cost of \$137,380 funded by FEMA's PDM Grant Program.

With funds from FEMA's Hazard Mitigation Grant Program (HMGP), a 10 by 3 by 40 foot bottomless aluminum culvert was placed under the railroad bed. The HMGP provides grants to states, Indian tribes, and local governments for long-term hazard mitigation projects following a major disaster declaration.

For historical accuracy under FEMA's Historic Preservation Program, the aluminum culvert was refaced with the original stone from the previous culvert. The aluminum culvert under the rail bed had to be completed before the box culvert under the road could be replaced. The brook was also returned to its original channel at this time. The cost of this project funded by the HMGP program was \$52,290.

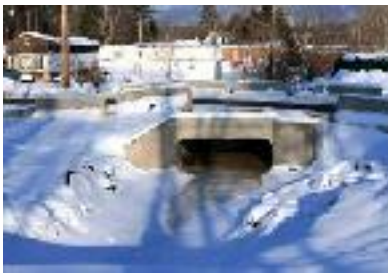
concrete and aluminum culverts
